**Flood Control Project Maintenance
Levee Inspections**

Maintenance Issue Types Only, Levee Inspection Report By Mile - Spring 2017

City of Sacramento

Waterway	Bank	Unit Miles	Inspection Start/End	Inspector
Unit No. 01 Sacramento River	Left	3.67	03/29/2017 03/29/2017	Zach Jojola

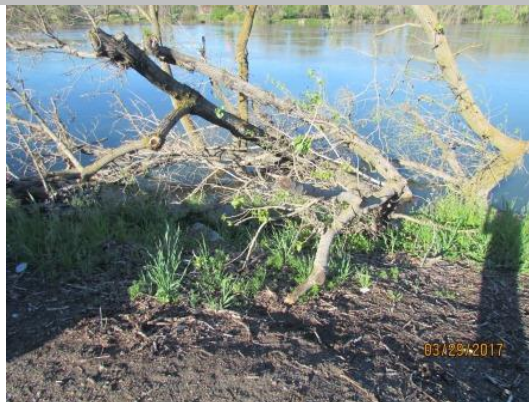
Photo 1 of 1 : SP_2017_NA0005_251_79_20170414_00138.jpg

LM Start	0.08	Rating **	M	Issue No.	79
LM End	0.08	Issue Type +	Ma	Location *	WS
Category	Earthen Levee		GPS Latitude/Longitude		
			Start	End	
Item	Encroachments		38.589690 °	38.589690 °	
			-121.505106 °	-121.505106 °	
DWR ID	DWR_NA0005_01_s_2017_79				
Comment Code					
TR : Tree or limb					
Inspector Comment					
Tree limbs on waterside slope.

Fallen tree limbs on the waterside levee slope, looking toward the Sacramento River. Spring 2017.

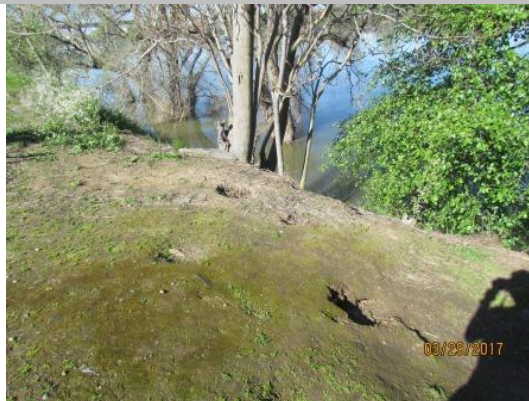
Photo 1 of 1 : SP_2017_NA0005_251_80_20170414_00139.jpg

LM Start	1.16	Rating **	M	Issue No.	80
LM End	1.16	Issue Type +	Ma	Location *	WS
Category	Earthen Levee			GPS Latitude/Longitude	
				Start	End
Item	Animal Control			38.574799 °	38.574799 °
				-121.510170 °	-121.510170 °
DWR ID	DWR_NA0005_01_s_2017_80				
Comment Code					
A3 : No rodents visible, but rodent burrows visible; need to backfill and compact or grout burrows.					
Inspector Comment

Multiple burrow holes on waterside levee slope. Spring 2017.

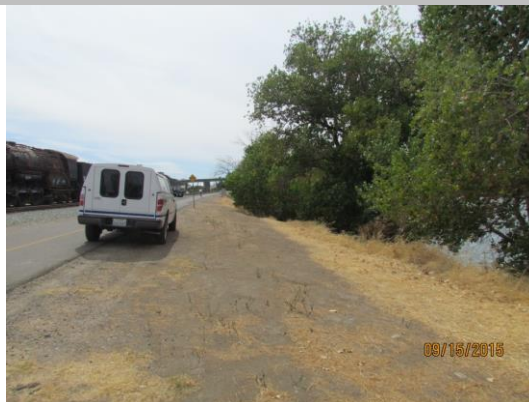
Photo 1 of 2 : SP_2017_NA0005_251_13_20170320_00010.jpg

LM Start	1.16	Rating **	M	Issue No.	13
LM End	1.69	Issue Type +	Ma	Location *	WS
Category	Earthen Levee			GPS Latitude/Longitude	
				Start	End
Item	Trim / Thin Trees			38.574780 °	38.568757 °
				-121.510191 °	-121.515930 °
DWR ID	DWR_NA0005_01_f_2012_13				
Comment Code					
T2 : Thin trees to allow visibility of the ground and room to flood fight.					
Inspector Comment

Monitor trees and woody vegetation along the rivers edge looking downstream. Fall 2015.

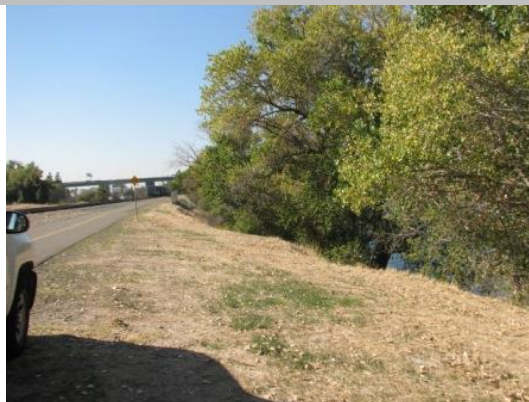
Photo 2 of 2 : SP_2017_NA0005_251_13_20170320_00011.jpg

LM Start	1.16	Rating **	M	Issue No.	13 (cont)
LM End	1.69	Issue Type +	Ma	Location *	WS

Monitor the trees and woody vegetation along the rivers edge. Fall 2013

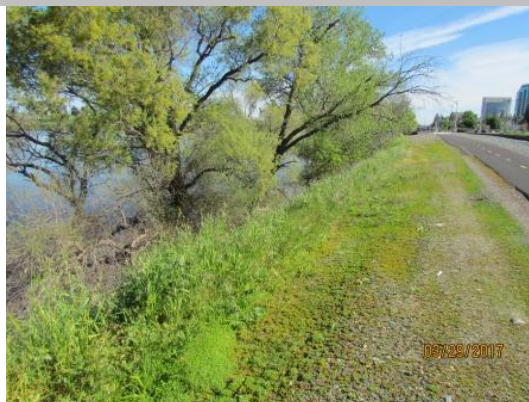
Photo 1 of 1 : SP_2017_NA0005_251_89_20170414_00141.jpg

LM Start	1.18	Rating **	M	Issue No.	89
LM End	1.70	Issue Type +	Ma	Location *	WS
Category	Earthen Levee			GPS Latitude/Longitude	
				Start	End
Item	Vegetation			38.574580 °	38.568512 °
				-121.510396 °	-121.516020 °
DWR ID	DWR_NA0005_01_s_2017_89				
Comment Code					
V1 : Control annual grass and weeds on the levee slopes and easements.					
Inspector Comment

Large grass blocking visibility on waterside levee slope. Spring 2017.

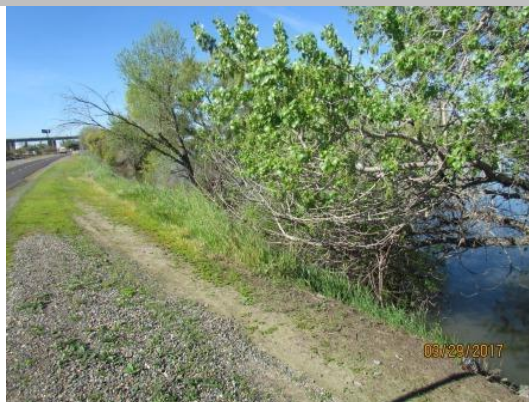
Photo 1 of 1 : SP_2017_NA0005_251_83_20170414_00140.jpg

LM Start	1.19	Rating **	M	Issue No.	83
LM End	1.19	Issue Type +	Ma	Location *	WS
Category	Earthen Levee			GPS Latitude/Longitude	
				Start	End
Item	Trim / Thin Trees			38.574404 °	38.574404 °
				-121.510542 °	-121.510542 °
DWR ID	DWR_NA0005_01_s_2017_83				
Comment Code					
T1 : Trim trees to at least five feet above ground level.					
Inspector Comment

Trim and thin trees on waterside levee slope. Spring 2017.

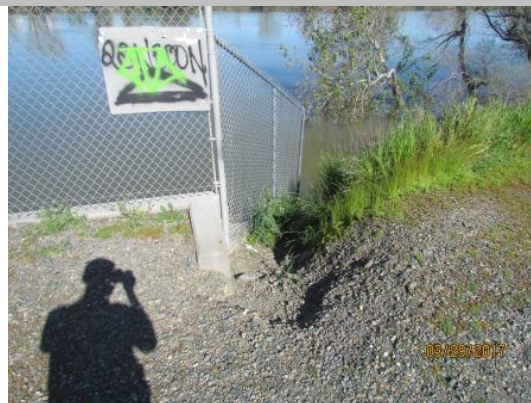
Photo 1 of 1 : SP_2017_NA0005_251_87_20170414_00142.jpg

LM Start	1.25	Rating **	M	Issue No.	87
LM End	1.25	Issue Type +	Ma	Location *	WS
Category	Earthen Levee			GPS Latitude/Longitude	
				Start	End
Item	Slope Stability			38.573791 °	38.573791 °
				-121.511161 °	-121.511161 °
DWR ID	DWR_NA0005_01_s_2017_87				
Comment Code					
S2 : Repair the levee slope damaged by foot traffic and prevent access where possible.					
Inspector Comment					
Footpath on waterside levee slope. Heavy traffic due to homeless camp at retaining wall.

Foot path digging into waterside levee slope. Spring 2017.

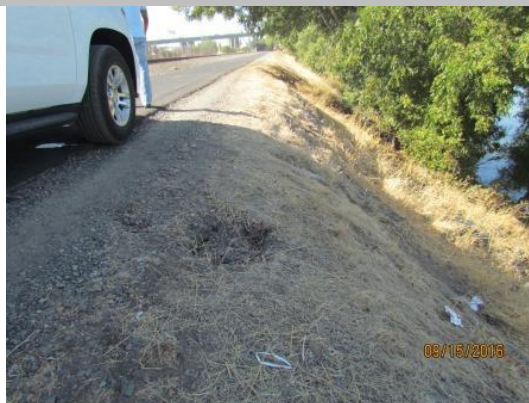
Photo 2 of 2 : SP_2017_NA0005_251_76_20170320_00015.jpg

LM Start	1.29	Rating **	M	Issue No.	76 (cont)	
LM End	1.29	Issue Type +	Ma	Location *	WS	
Category	Earthen Levee			GPS Latitude/Longitude		
				Start	End	
Item	Animal Control			38.573240 °	38.573240 °	
				-121.511707 °	-121.511707 °	
DWR ID	DWR_NA0005_01_s_2017_76					
Comment Code						
A3 : No rodents visible, but rodent burrows visible; need to backfill and compact or grout burrows.						
Inspector Comment

Rodent hole backfilled with natural soil on waterward side of the levee.
Fall 2016 inspection.

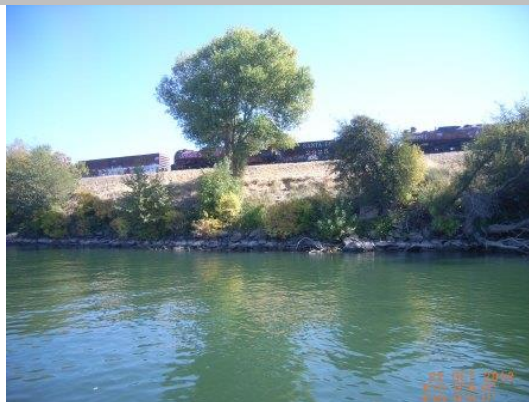
Photo 1 of 2 : SP_2017_NA0005_251_1_20170320_00001.jpg

LM Start	1.31	Rating **	M	Issue No.	1
LM End	1.39	Issue Type +	Ma	Location *	WS
Category	Supplemental			GPS Latitude/Longitude	
				Start	End
Item	2015 USACE Erosion Survey, DRAFT			38.573169 °	38.572277 °
				-121.511998 °	-121.513063 °
DWR ID	DWR_NA0005_01_s_2016_1				
Comment Code					
Inspector Comment					
2008 - Oversized levee, should be repaired under maintenance. 2009 - Shallow slumps at the mid bank. 2010 - Some minor erosion at the toe, likely from wave wash. Some new shallow slumps. 2011 - One new tree has fallen. 2013 - Erosion continues on the slope surface, site extended upstream. 2015: No observed changes. [2015 Site ID: SAC 58-5 L]

USACE 2013 Photo #1

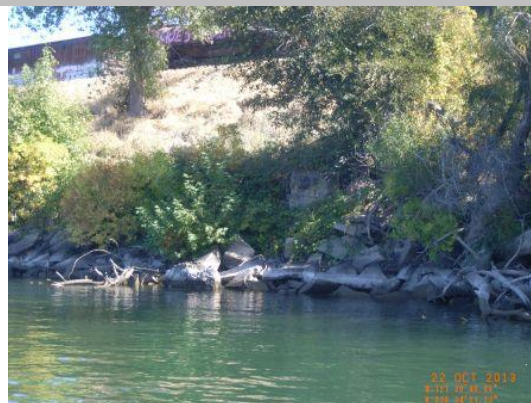
Photo 2 of 2 : SP_2017_NA0005_251_1_20170320_00002.jpg

LM Start	1.31	Rating **	M	Issue No.	1 (cont)
LM End	1.39	Issue Type +	Ma	Location *	WS
Category	Supplemental			GPS Latitude/Longitude	
				Start	End
Item	2015 USACE Erosion Survey, DRAFT			38.573169 °	38.572277 °
				-121.511998 °	-121.513063 °
DWR ID	DWR_NA0005_01_s_2016_1				
Comment Code					
Inspector Comment					
2008 - Oversized levee, should be repaired under maintenance. 2009 - Shallow slumps at the mid bank. 2010 - Some minor erosion at the toe, likely from wave wash. Some new shallow slumps. 2011 - One new tree has fallen. 2013 - Erosion continues on the slope surface, site extended upstream. 2015: No observed changes. [2015 Site ID: SAC 58-5 L]

USACE 2013 Photo #2

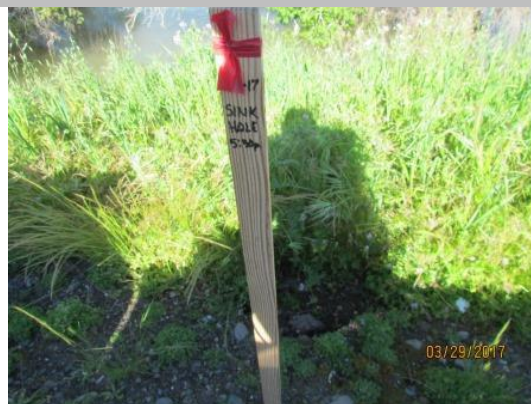
Photo 1 of 1 : SP_2017_NA0005_251_88_20170414_00143.jpg

LM Start	1.46	Rating **	M	Issue No.	88
LM End	1.46	Issue Type +	Ma	Location *	WS
Category	Earthen Levee			GPS Latitude/Longitude	
				Start	End
Item	Erosion / Bank Caving			38.571462 °	38.571462 °
				-121.513810 °	-121.513810 °
DWR ID	DWR_NA0005_01_s_2017_88				
Comment Code					
E1 : Note and monitor erosion site.					
Inspector Comment					
Sink hole on waterside levee slope near crown.

Sink hole on waterside levee slope near crown. Spring 2017.

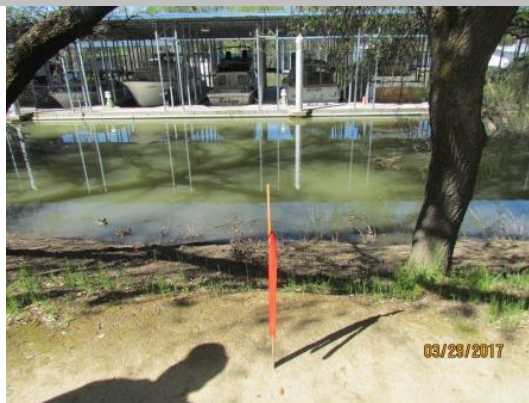
Photo 1 of 1 : SP_2017_NA0005_251_86_20170414_00147.jpg

LM Start	2.16	Rating **	A/W	Issue No.	86
LM End	2.16	Issue Type +	Ma	Location *	WS
Category	Earthen Levee			GPS Latitude/Longitude	
				Start	End
Item	Erosion / Bank Caving			38.562024 °	38.562024 °
				-121.515923 °	-121.515923 °
DWR ID	DWR_NA0005_01_s_2017_86				
Comment Code					
E1 : Note and monitor erosion site.					
Inspector Comment					
Erosion on wateside slope. Marked on March 17, 2017

Erosion on wateside slope that appers to be underwater. Marked on March 17, 2017. Spring 2017.

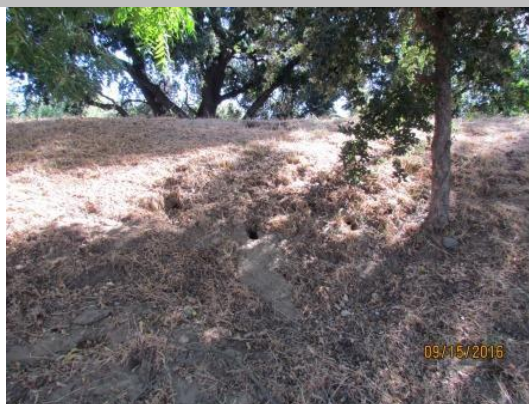
Photo 1 of 1 : SP_2017_NA0005_251_77_20170320_00016.jpg

LM Start	2.30	Rating **	M	Issue No.	77
LM End	2.30	Issue Type +	Ma	Location *	WS
Category	Earthen Levee			GPS Latitude/Longitude	
				Start	End
Item	Animal Control			38.559889 °	38.559889 °
				-121.515341 °	-121.515341 °
DWR ID	DWR_NA0005_01_f_2016_77				
Comment Code					
A1 : Exterminate rodents and backfill and compact or grout burrows.					
Inspector Comment

More squirrel holes found on waterward slope. Fall 2016.

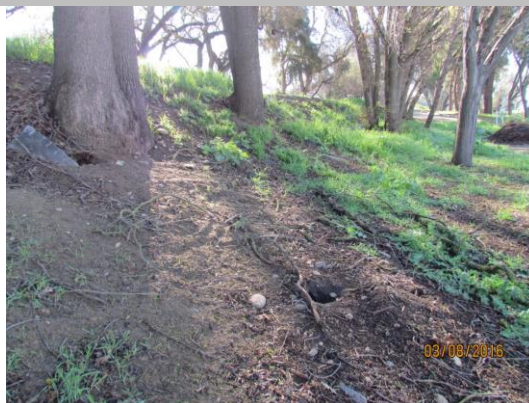
Photo 1 of 1 : SP_2017_NA0005_251_82_20170320_00018.jpg

LM Start	2.31	Rating **	M	Issue No.	82
LM End	2.31	Issue Type +	Ma	Location *	WS
Category	Earthen Levee			GPS Latitude/Longitude	
				Start	End
Item	Animal Control			38.559767 °	38.559767 °
				-121.515264 °	-121.515264 °
DWR ID	DWR_NA0005_01_s_2016_82				
Comment Code					
A3 : No rodents visible, but rodent burrows visible; need to backfill and compact or grout burrows.					
Inspector Comment

View of the rodent holes on the waterward side of the levee looking downstream. Spring 2016.

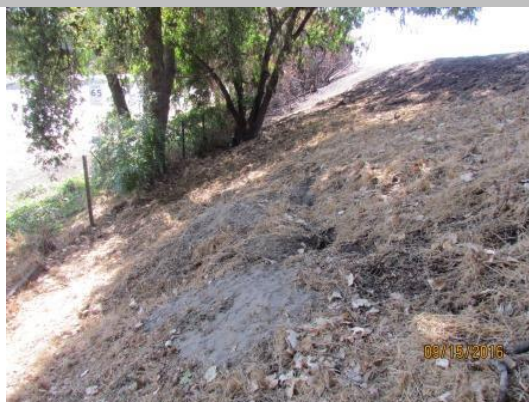
Photo 1 of 1 : SP_2017_NA0005_251_78_20170320_00017.jpg

LM Start	2.43	Rating **	U	Issue No.	78
LM End	2.43	Issue Type +	Ma	Location *	LS
Category	Earthen Levee			GPS Latitude/Longitude	
				Start	End
Item	Animal Control			38.558281 °	38.558281 °
				-121.514393 °	-121.514393 °
DWR ID	DWR_NA0005_01_f_2015_78				
Comment Code					
A1 : Exterminate rodents and backfill and compact or grout burrows.					
Inspector Comment

Rodent holes with more than 2 cub ft. of soil taken out found on landside slope of the levee. Fall 2016.

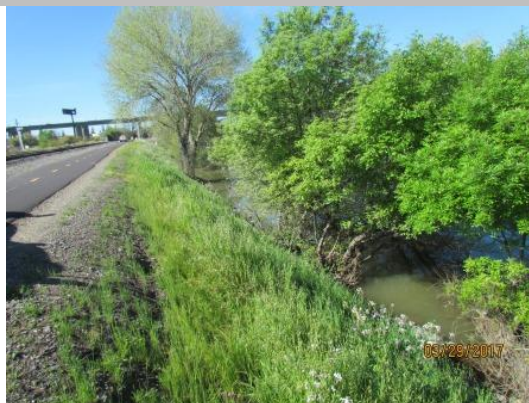
Photo 1 of 1 : SP_2017_NA0005_251_92_20170414_00146.jpg

LM Start	2.44	Rating **	M	Issue No.	92
LM End	3.67	Issue Type +	Ma	Location *	WS
Category	Earthen Levee			GPS Latitude/Longitude	
				Start	End
Item	Vegetation			38.558122 °	38.541081 °
				-121.514366 °	-121.511482 °
DWR ID	DWR_NA0005_01_s_2017_92				
Comment Code					
V1 : Control annual grass and weeds on the levee slopes and easements.					
Inspector Comment

Tall vegetation on waterside levee slope, blocking visibility. Spring 2017.

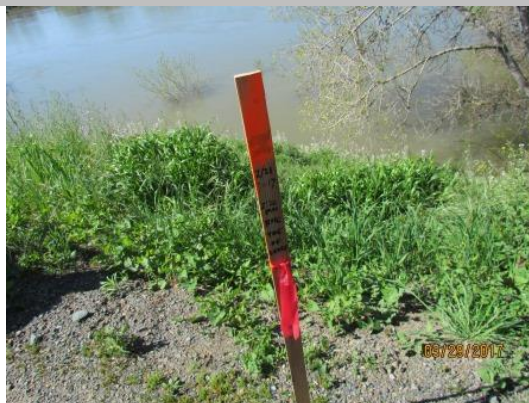
Photo 1 of 1 : SP_2017_NA0005_251_95_20170414_00148.jpg

LM Start	2.45	Rating **	A/W	Issue No.	95
LM End	2.45	Issue Type +	Ma	Location *	WS
Category	Earthen Levee			GPS Latitude/Longitude	
				Start	End
Item	Erosion / Bank Caving			38.557890 °	38.557890 °
				-121.514249 °	-121.514249 °
DWR ID	DWR_NA0005_01_s_2017_95				
Comment Code					
E1 : Note and monitor erosion site.					
Inspector Comment					
Erosion on waterside levee toe staked during February high water event.

Erosion on waterside levee toe staked during February high water event.
The erosion appears to be underwater. Spring 2017.

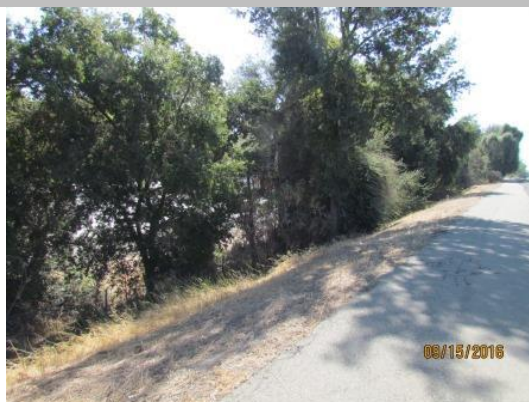
Photo 1 of 1 : SP_2017_NA0005_251_84_20170320_00019.jpg

LM Start	2.52	Rating **	M	Issue No.	84
LM End	2.92	Issue Type +	Ma	Location *	LS
Category	Earthen Levee			GPS Latitude/Longitude	
				Start	End
Item	Vegetation			38.556964 °	38.551504 °
				-121.513926 °	-121.511746 °
DWR ID	DWR_NA0005_01_s_2016_84				
Comment Code					
V2 : Remove the wild growth other than native grasses from the levee slopes.					
Inspector Comment

View of landside slope. Tree trimming and vegetation removal required.
Fall 2016.

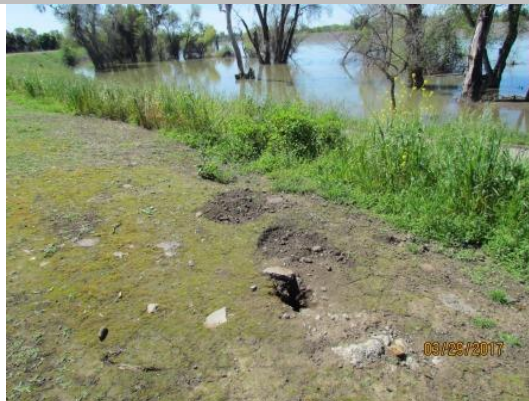
Photo 1 of 1 : SP_2017_NA0005_251_99_20170414_00150.jpg

LM Start	3.06	Rating **	M	Issue No.	99
LM End	3.06	Issue Type +	Ma	Location *	WS
Category	Earthen Levee			GPS Latitude/Longitude	
				Start	End
Item	Animal Control			38.549504 °	38.549504 °
				-121.511019 °	-121.511019 °
DWR ID	DWR_NA0005_01_s_2017_99				
Comment Code					
A1 : Exterminate rodents and backfill and compact or grout burrows.					
Inspector Comment					
Burrows on waterside levee slope

Burrows on waterside levee slope, looking towards Sacramento River.
Spring 2017.

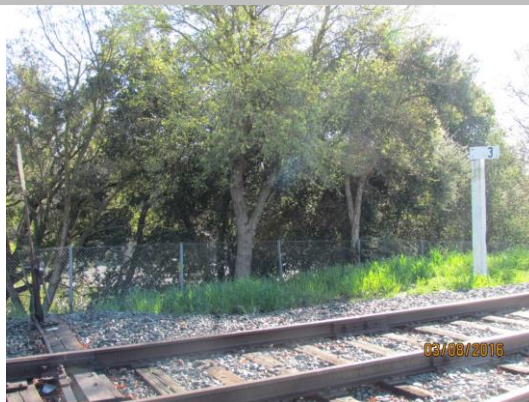
Photo 1 of 2 : SP_2017_NA0005_251_85_20170320_00020.jpg

LM Start	3.35	Rating **	M	Issue No.	85
LM End	3.35	Issue Type +	Ma	Location *	LS
Category	Earthen Levee			GPS Latitude/Longitude	
				Start	End
Item	Trim / Thin Trees			38.545403 °	38.545403 °
				-121.509830 °	-121.509830 °
DWR ID	DWR_NA0005_01_s_2016_85				
Comment Code					
T3 : Trim and thin trees to allow visibility of the ground and room to flood fight.					
Inspector Comment

View of the trees on the landward side of the levee. Spring 2016.

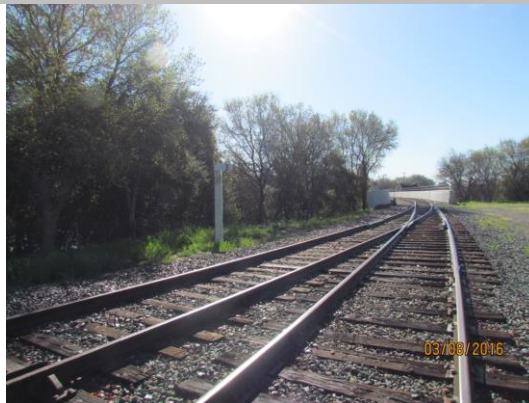
Photo 2 of 2 : SP_2017_NA0005_251_85_20170320_00021.jpg

LM Start	3.35	Rating **	M	Issue No.	85 (cont)	
LM End	3.35	Issue Type +	Ma	Location *	LS	
Category	Earthen Levee			GPS Latitude/Longitude		
				Start		End
Item	Trim / Thin Trees			38.545403 °		38.545403 °
				-121.509830 °		-121.509830 °
DWR ID	DWR_NA0005_01_s_2016_85					
Comment Code						
T3 : Trim and thin trees to allow visibility of the ground and room to flood fight.						
Inspector Comment

Perspective view of the trees on the landward side of the levee looking downstream. Spring 2016.

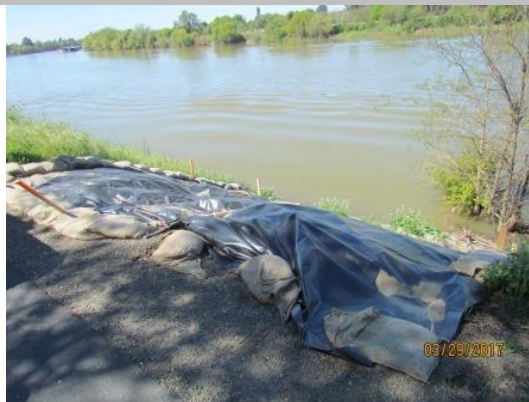
Photo 1 of 1 : SP_2017_NA0005_251_100_20170414_00151.jpg

LM Start	3.61	Rating **	M	Issue No.	100
LM End	3.61	Issue Type +	Ma	Location *	WS
Category	Earthen Levee			GPS Latitude/Longitude	
				Start	End
Item	Erosion / Bank Caving			38.541912 °	38.541912 °
				-121.511014 °	-121.511014 °
DWR ID	DWR_NA0005_01_s_2017_100				
Comment Code					
E1 : Note and monitor erosion site.					
Inspector Comment

Sloughing on waterside levee slope. City of Sacramento placed raincoat to prevent further erosion. Spring 2017.
